## Exploring the features of plants threatening Malaysia's heritage buildings

Plant characteristics,  
landscape plants,  
threatening plants,  
building conservation,  
heritage building

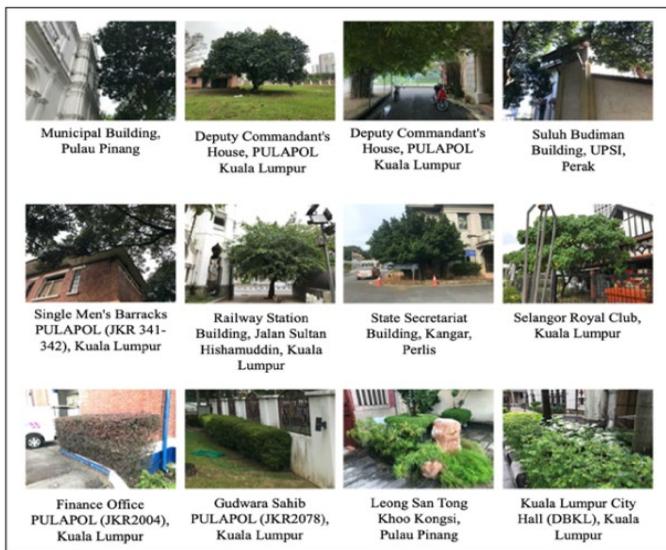
Clumping plants include palms, bamboo, and herbaceous species. Clumping palms are often planted in rows as visual buffers or screens. When planted closely together, their shading effect is almost the same as that of woody trees. K2 reported that palm trees near the Sultan Abdul Samad Building were cut down due to excessive moisture at the base of the walls. Clumping bamboo species are usually planted at the corners of buildings or in fence areas to block views from adjacent areas. Clumping herb species are also used in the same way, namely planted near buildings as screens. Although not numerous, these clumping plants form a dense structure that blocks sunlight and increases humidity on the walls of buildings. Dense-leaved climbers also pose a threat by retaining moisture on the surfaces they cover. These species cling to the walls and increase humidity levels. Among the heritage buildings identified to have this type of climber are Christ Church in Melaka, Bangunan Kelab Diraja Selangor, Masjid Alwi, and Sekolah Menengah King George V in Seremban (Figure 2).

Figure 2: The location of heritage buildings with compact canopy.

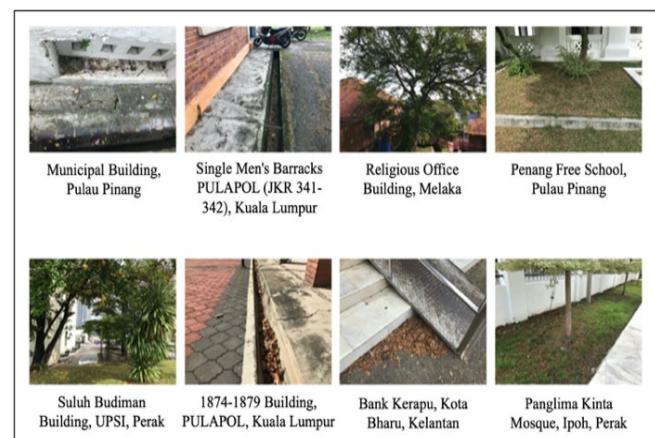
On-site observations also confirmed that deciduous trees planted outside the building area can also cause waste problems inside the building area. On the other hand, trees with dense leaves usually cause leaf litter to accumulate near the base of the tree. A total of 34 species of deciduous trees that continuously shed their leaves have been identified and require daily maintenance. Among these species are *Adenanthera pavonina*, *Azadirachta indica*, *Peltophorum pterocarpum*, *Phyllanthus emblica*, *Samanea saman* and *Terminalia catappa*, which have a significant impact because they have fine and light leaves, are difficult to clean and often clog drainage systems and gutters.

Figure 3: The view and condition of the heritage buildings area with fallen leaves surrounding the heritage buildings before it was cleaned.

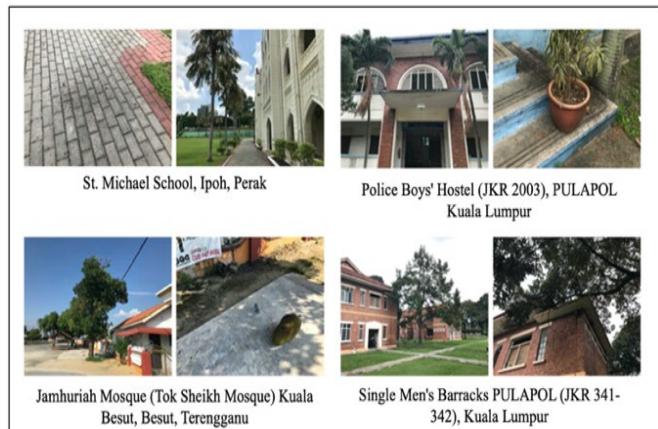
According to K1, K2, K3, K4, K5, K6 and K8, fruit trees attract bats, which eat the fruit and leave behind their droppings and fruit waste when perching on buildings. K2, K3, K4 and K5 observed that bats often hang from exposed roof beams or rafters near rainwater drains, where their fruit waste and droppings accumulate on floors, platforms and walls. K2 also stated that the location of fruit trees too close to buildings causes the walls to be contaminated with bat droppings and

food waste (Figure 4). Fruits favoured by bats are generally soft and small, such as *Syzygium aqueum*, *Syzygium jambos*, *Lansium domesticum* Corr., *Ficus fistulosa*, *Ficus variegata*, *Dimocarpus longan*, *Nephelium lappaceum*, *Nephelium mutabile* and *Manilkara zapota*. K8 identified rose apples and mangoes (*Mangifera indica*) as frequently brought into buildings by bats. Beyond bats, K3 reported that civets also carry fruit into buildings, leaving behind faeces and fruit waste that require frequent cleaning. Birds nesting in buildings further increase this threat. The fruits they consume are small and often contain undigested seeds. According to K4, these seeds easily become trapped in the carvings and crevices of heritage buildings, potentially sprouting into unwanted plants. K4 further warned that introducing green building concepts to heritage structures, without proper adaptation, may worsen existing damage.

Figure 4: Fruit-bearing plants contribute to debris around the heritage building.

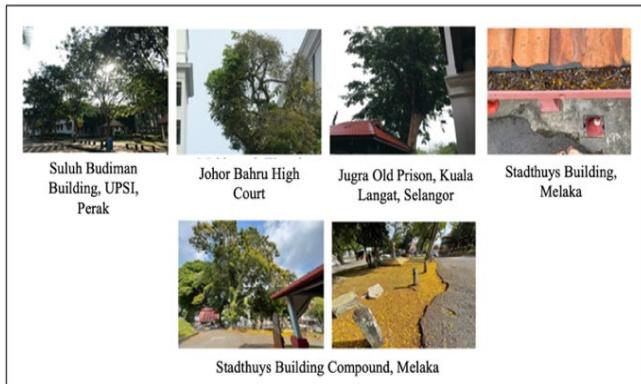
Figure 5: Debris from seasonal flowering plants planted around the heritage buildings.

According to K4, the presence of flowers on heritage buildings is often attributed to wind dispersion. This was observed at Surau Jamhuria (Tok Sheikh Surau) in Kuala Besut, where the flowers of *Bougainvillea spectabilis* (bunga kertas), planted one metre from the building, were blown by the wind and accumulated in the drainage system. Similar occurrences were recorded at the Stadthuys building, Christ Church, Museum building, Irrigation Office, and Religious Office buildings in Melaka, *Peltophorum pterocarpum* (Yellow Flame tree) was planted nearby, resulting in fallen flowers becoming trapped and accumulated in gutters and drains. While flower droppings can enhance the valuable experience for visitors by creating a beautiful view like a yellow carpet, they can also have a negative impact on heritage buildings. Observations have shown that flower debris accumulates in the roof gutters even though the plants are up to eight (8) metres away from the building. This is due to the sea breeze carrying the flowers towards the building.

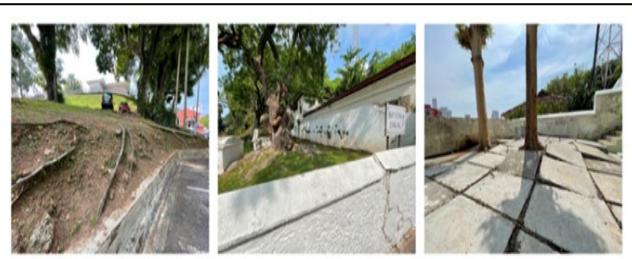
Plants with creeping or spreading root systems on the surface have been identified as a cause of structural cracking in heritage buildings. According to K3, K4, K5, K6 and K7, such damage is usually caused by plants growing too close to the building structure. K4 emphasizes that plants with aggressive root systems should be avoided near heritage buildings to maintain structural stability (Figure 6). Damage caused by roots is difficult to detect in the early stages as it occurs underground and usually requires excavation work to confirm (Awang et al., 2024; Jim, 2018; Mattheck et al., 2003).

Figure 6: Exposed creeping roots can be seen damaging the nearby structure at the Old State Legislative Assembly Building, Melaka.

K3 explains that root barriers or root walls are used to prevent or divert root growth, while K2 adds that root pruning is carried out when encroachment is detected. K2 and K7 suggest the use of potted plants to limit root growth and facilitate maintenance. K4 and K5 emphasize that trees such as *Samanea saman* have wide-spreading roots and often damage building structures. K4 also suggests that all plants within a one-meter radius of a heritage building be removed as this distance represents the root growth range. K6 also recommends that shrubs and shade trees be planted at least 2 to 3 meters away from buildings to avoid damage.

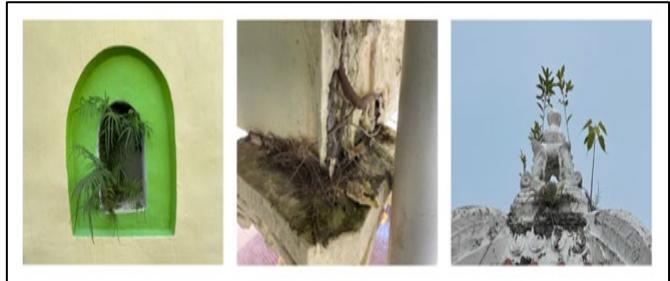
Apart from lateral roots, plants with adventitious roots have also been identified as threats to heritage buildings. Unlike lateral roots, adventitious roots are more visible, and the damage they cause can be detected with the naked eye. These roots do not originate from the main root system but emerge from stems or branches, attaching themselves to building surfaces. Species such as *Ficus spp.* produce adventitious roots that grip and encircle structures, starting as fine roots that thicken and harden over time (Figure 7). The extent of damage depends on the plant's size and growth, the larger the plant, the greater the damage due to its strong grip on the building.

Figure 7: Ferns and *Ficus* species growing and thriving on the ventilation openings, beams, and roof crown of Serkam Pantai Mosque, Jasin, Melaka.

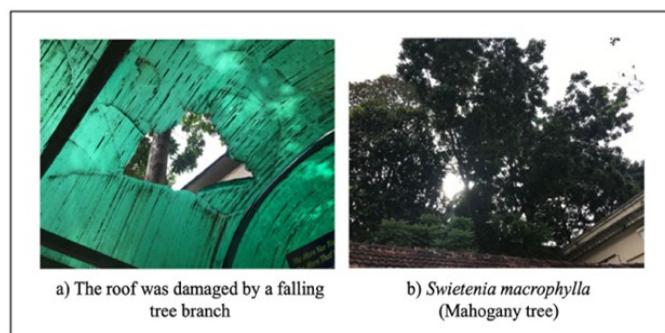
K3 reported large, hazardous trees along Jalan Kota in Melaka, near the Islamic Museum and Irrigation Office. Observations during rainfall showed scattered leaves and twigs around drains and buildings. K2 and K7 noted fallen

branches damaging government quarters in Kuching during conservation works, while at King George V School in Seremban, *Swietenia macrophylla* branches damaged a covered walkway (Figure 8).

Figure 8: A fallen branch of the *Swietenia macrophylla* or mahogany tree that struck the roof of SMK King George V, Seremban, Negeri Sembilan.

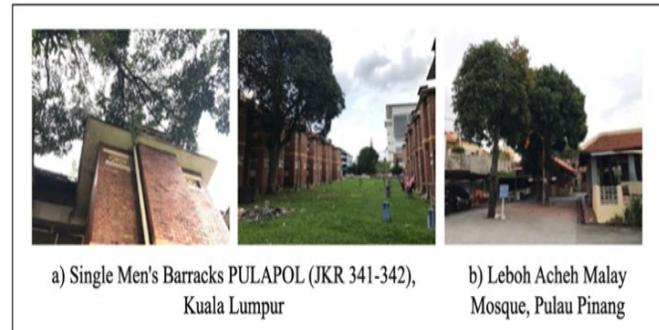
However, observations have shown that almost all plants around heritage buildings have expanded their canopy to touch or cover the roof. This situation contributes to moisture problems on the walls of the building (Figure 9). K1 explained that *Mangifera indica* is a traditional plant of the

Baba and Nyonya communities in Melaka and Penang that is usually planted in front of the house. If not pruned properly, even distant trees can have an impact on the building. K4 shared that *Samanea saman* trees in Taiping that were planted too close to the building have caused rainwater to seep through the walls. Trees with wide canopies like this require careful planning before planting as their growth is difficult to control when mature. Although they provide shade, these trees also produce a large amount of debris.

Figure 9: A *Mangifera indica* (mango tree) providing shade to the heritage building.
