Journal of Tropical Resources and Sustainable Science

Determination and Prediction of Corrosion Integrity on RV Discovery Via Non-Destructive Test (NDT) And Artificial Neural Network (ANN)

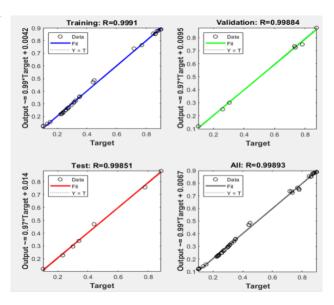
Figure 7: Regression plot for the training, validation, and testing dataset for prediction of deterioration rate.

Neuron number 3 shows the best R and MSE value of 0.99893 and 2.16 x 10^{-4} respectively. Figure 7 represents the regression plot for training, testing and validation of the dataset. Regression R values measure the correlation between outputs and targets. The R values for training, validation and test are 0.9991, 0.99884 and 0.99851 respectively, yielding an overall R-value of 0.99893. This clearly indicates the ANN has a 99%

confidence in predicting the deterioration rate of RV-Discovery.

The accuracy of the network was evaluated by the mean squared error (MSE) and the regression (R) is measure of how well the regression line represents the actual data set. It can vary from 0 to 1. An R value close to 1 indicates that the ANN model perfectly predicts the output. The SCG training algorithm uses unconventional methods to search for the weight of each path which produces faster convergence (Møller, 1993). The gradient descent method uses reference points plotted to find the lowest point in the model and uses more epochs to get the best results (bin Zulkifli *et al.*, 2021, al Bataineh and Kaur, 2018). Hence it is selected as a training algorithm in this study.
